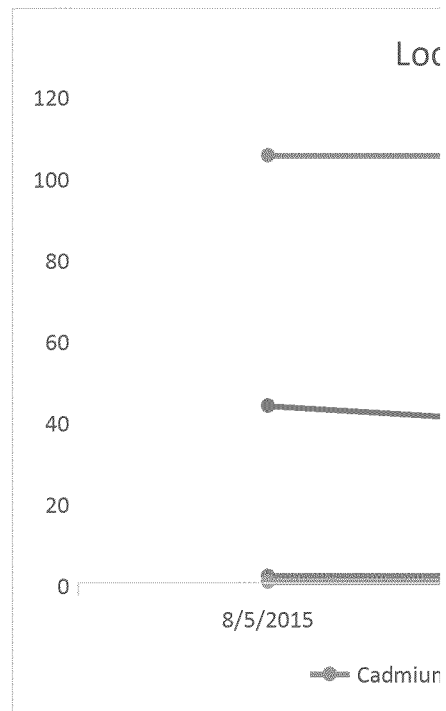
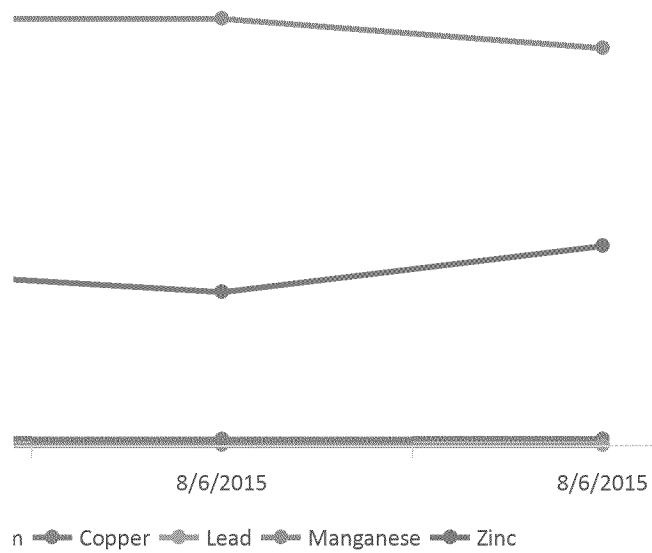
Location: 32nd Street Bridge

ocation ID	Date Sampled	Cadmium	Copper	Lead	Manganese	Zinc
32nd St Br	8/5/2015	0.178	1.7	0.24	105	43.5
32nd St Br	8/6/2015	0.16	1.56		105	37.8
32nd St Br	8/6/2015	0.19	1.62	0.115	97.8	49.1

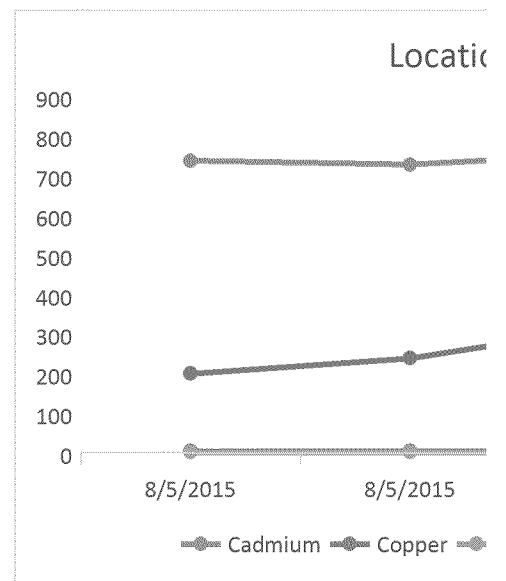
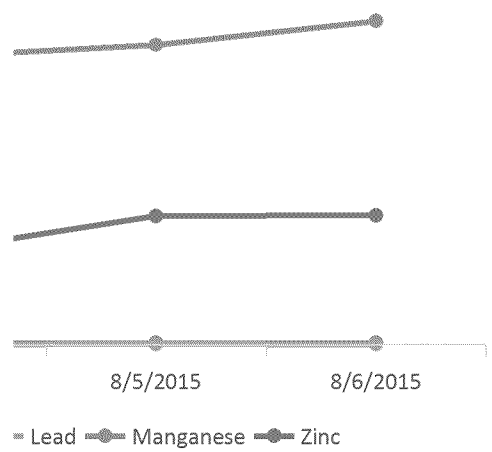
on: A68

Location ID	Date Sampled	Cadmium	Copper	Lead	Manganese	Zinc
A68	8/5/2015	0.828	3.45	0.232	737	199
A68	8/5/2015	0.815	3.16	0.283	727	238
A68	8/5/2015	0.974	3.52	0.82	757	324
A68	8/6/2015	0.85	3.26	0.329	817	326

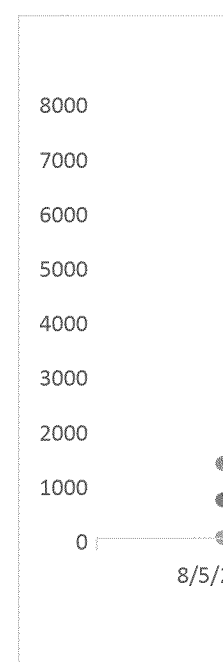
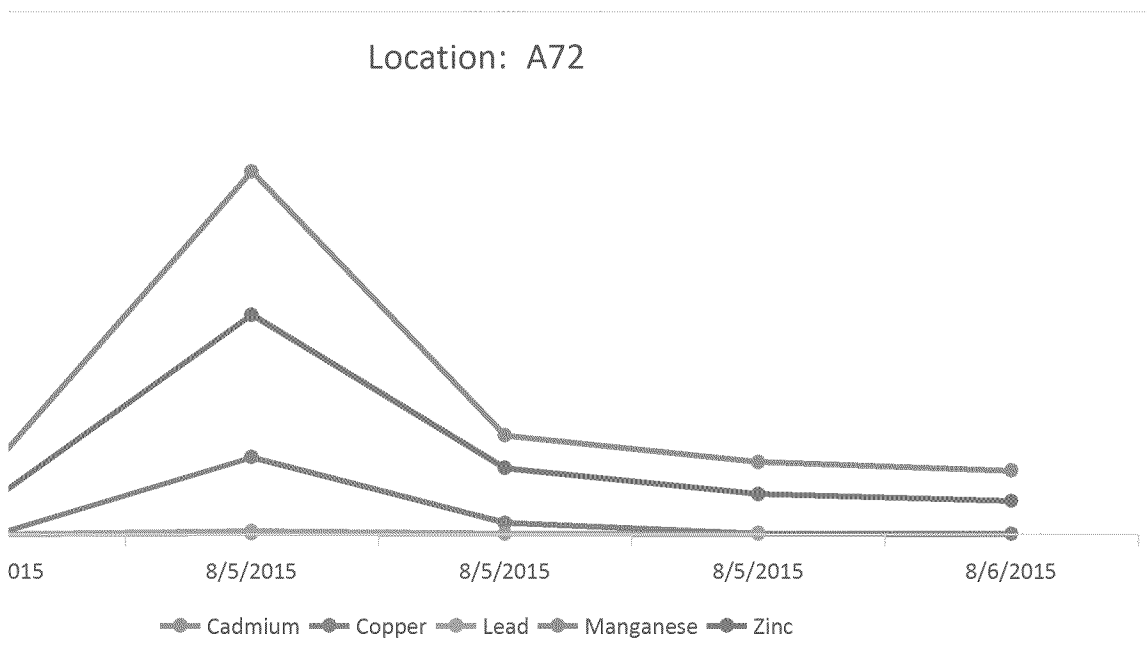
Location ID	De Sampled	Cadmium	Copper	Lead	Manganese	Zinc
A72	8/5/2015	1.81	9.27	0.225	1370	699
A72	8/5/2015	15.2	1410	50.7	6650	4020
A72	8/5/2015	4.29	205	3.12	1810	1210
A72	8/5/2015	2.59	11.4	0.118	1320	733
A72	8/6/2015	2.11	7.63		1160	609

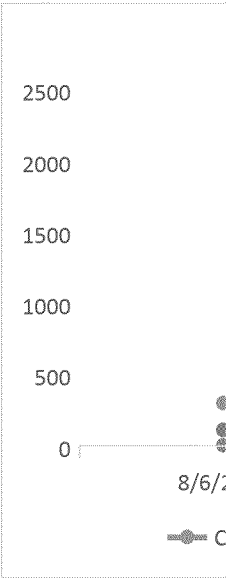
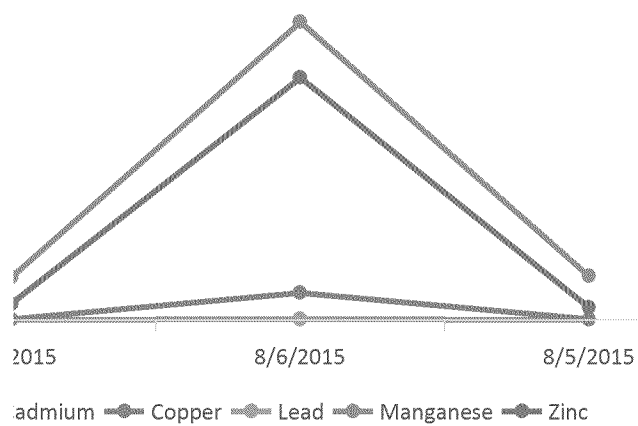
Location: Bakers Bridge

ocation ID	De Sampled	Cadmium	Copper	Lead	Manganes	Zinc
Bakers Bri	8/6/2015	0.336	1.88		296	110
Bakers Bri	8/6/2015	5.32	189	1.56	2090	1700
Bakers Bri	8/5/2015	0.353	2.28		306	85.8

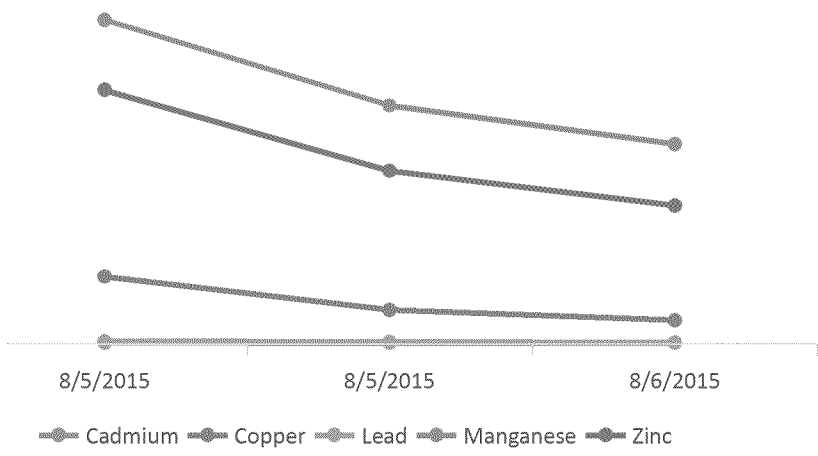
Location: CC48

ocation ID	Sampled	Cadmium	Copper	Lead	Manganese	Zinc
CC48	8/5/2015	30.6	2260	73.9	10900	8540
CC48	8/5/2015	19.1	1130	54.1	8020	5820
CC48	8/6/2015	14.2	786	30	6720	4650

12000
10000
8000
6000
4000
2000
0
